Manhole Inspection Summary

Manhole # S13EE_025MH

Insp Date: **2/19/09 3:49 PM**

Location Address: **2800 PRESSTMAN ST**

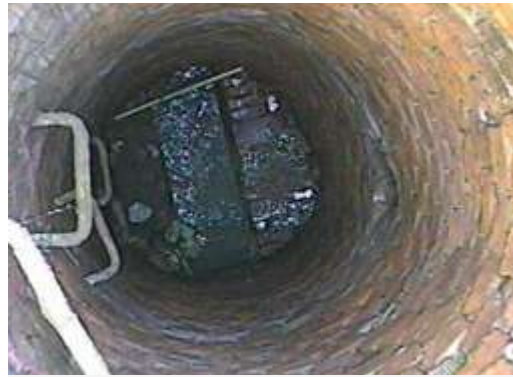
Top View

DEBRIS ON BENCH AND ON CHANNEL

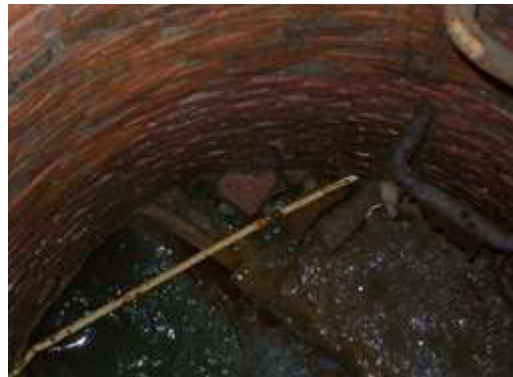
Defect 1

Condition: ☐ Sound ☐ Cracked ☐ Root Intrusion ☒ **Deteriorated** ☐ Leaks ☐ Debris

BRICKS MISSING FROM BENCH

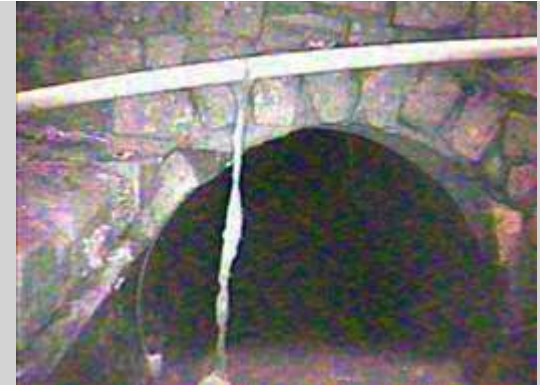
12 O'Clock Outflow

Pipe Height: **18** (in.) Rod and Bar (Angled)
Pipe Material: **Clay** ☐ Pipe Lined
Invert Depth: **13.73** (ft.) Flow Characteristics: **Slow**
Deposits: ☒ None ☐ Mud ☐ Sludge ☐ Debris ☐ Grease
Silt Depth: (in.) Deposits Extent:
Infiltration: **None** Pipe Seal Cond: **Broken**

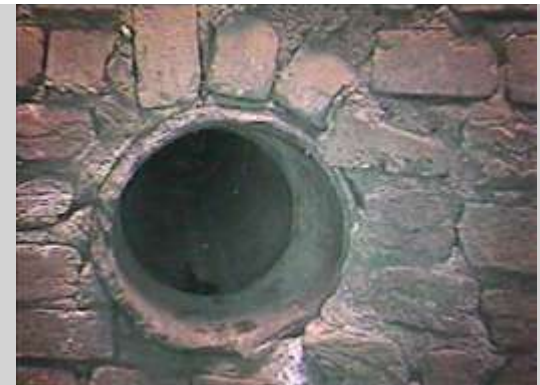
3 O'Clock Inflow

Pipe Height: **9.6** (in.) Rod and Bar (Angled)
Pipe Material: **Clay** ☐ Pipe Lined
Invert Depth: **6.64** (ft.) Flow Characteristics: **Slow**
Deposits: ☒ None ☐ Mud ☐ Sludge ☐ Debris ☐ Grease
Silt Depth: (in.) Deposits Extent:
Infiltration: **None** Pipe Seal Cond: **Cracked**

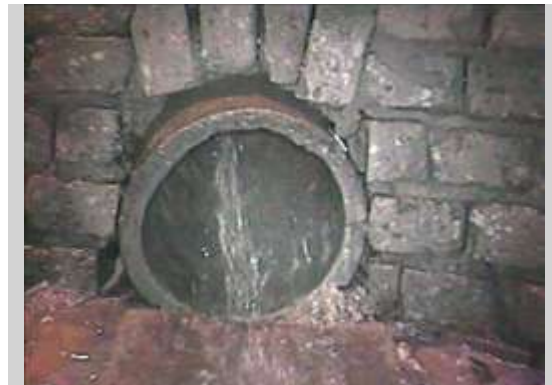
Drop In @ 3 O'Clock

Drop: **Outside Direct**

Drop Condition: **Open**

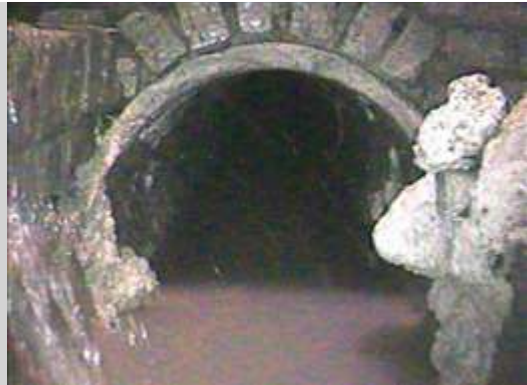
6 O'Clock Inflow

Infiltration: **None** Pipe Seal Cond: **Sound**
